## SITE CERTIFICATION SUMMARY

This Site Certification Summary provides information about the **Aliquippa, Pennsylvania, Site**. The U.S. Department of Energy Office of Legacy Management is responsible for long-term stewardship of the site under the **Formerly Utilized Sites Remedial Action Program**.

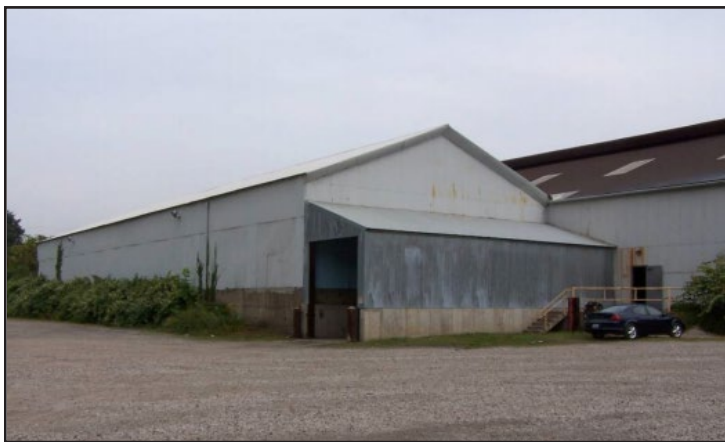
Front of remediated building at the Aliquippa site (September 2005).

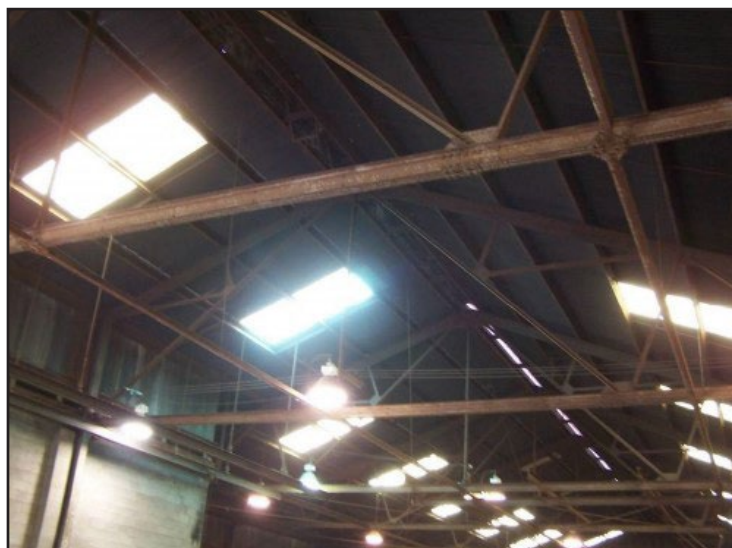
*Roof system where supplemental limits were applied at the Aliquippa site (September 2005).*

assessment justified the establishment of supplemental limits for the roof panel joints, the area between the roof panels and purlins containing contaminated dust and debris, and the three concrete support pedestals in Building 3. The exposure risk to workers and members of the public was very low relative to the high cost of performing remedial action.
